AFWAL-TR-82-2121
Volume I

STRUCTURAL ELEMENT AND REAL BLADE IMPACT TESTING

UNIVERSITY OF DAYTON RESEARCH INSTITUTE
300 COLLEGE PARK AVENUE
DAYTON, OHIO 45469

FINAL REPORT FOR PERIOD OCTOBER 1977 - JUNE 1980

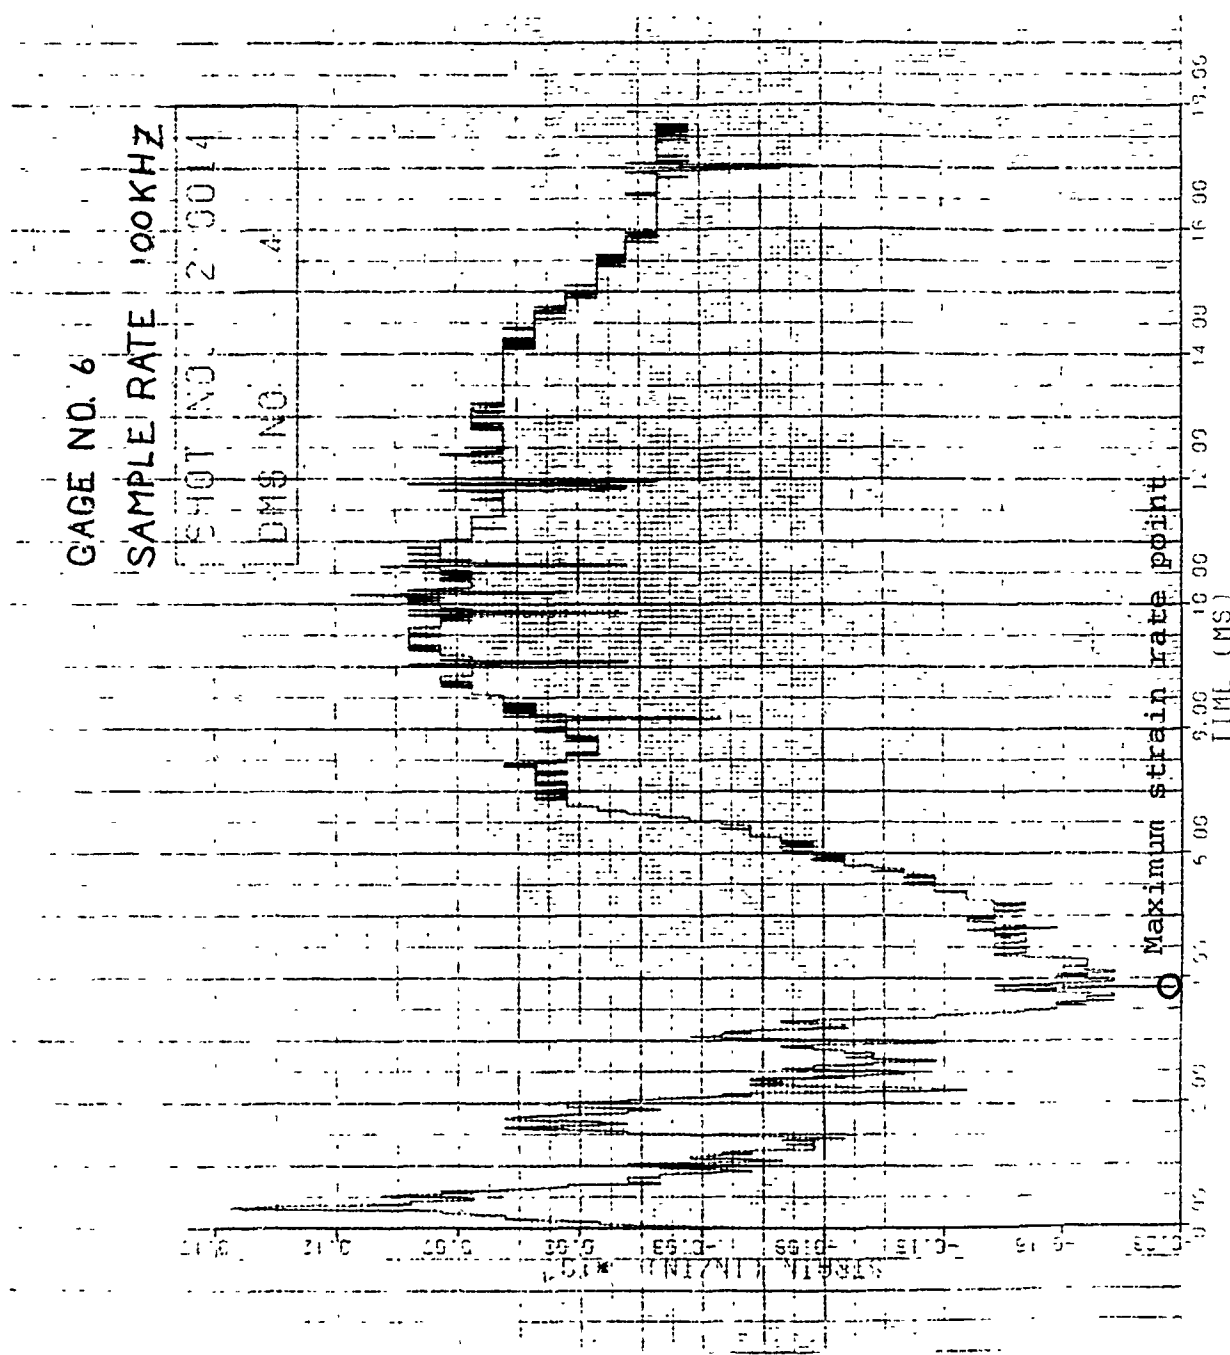
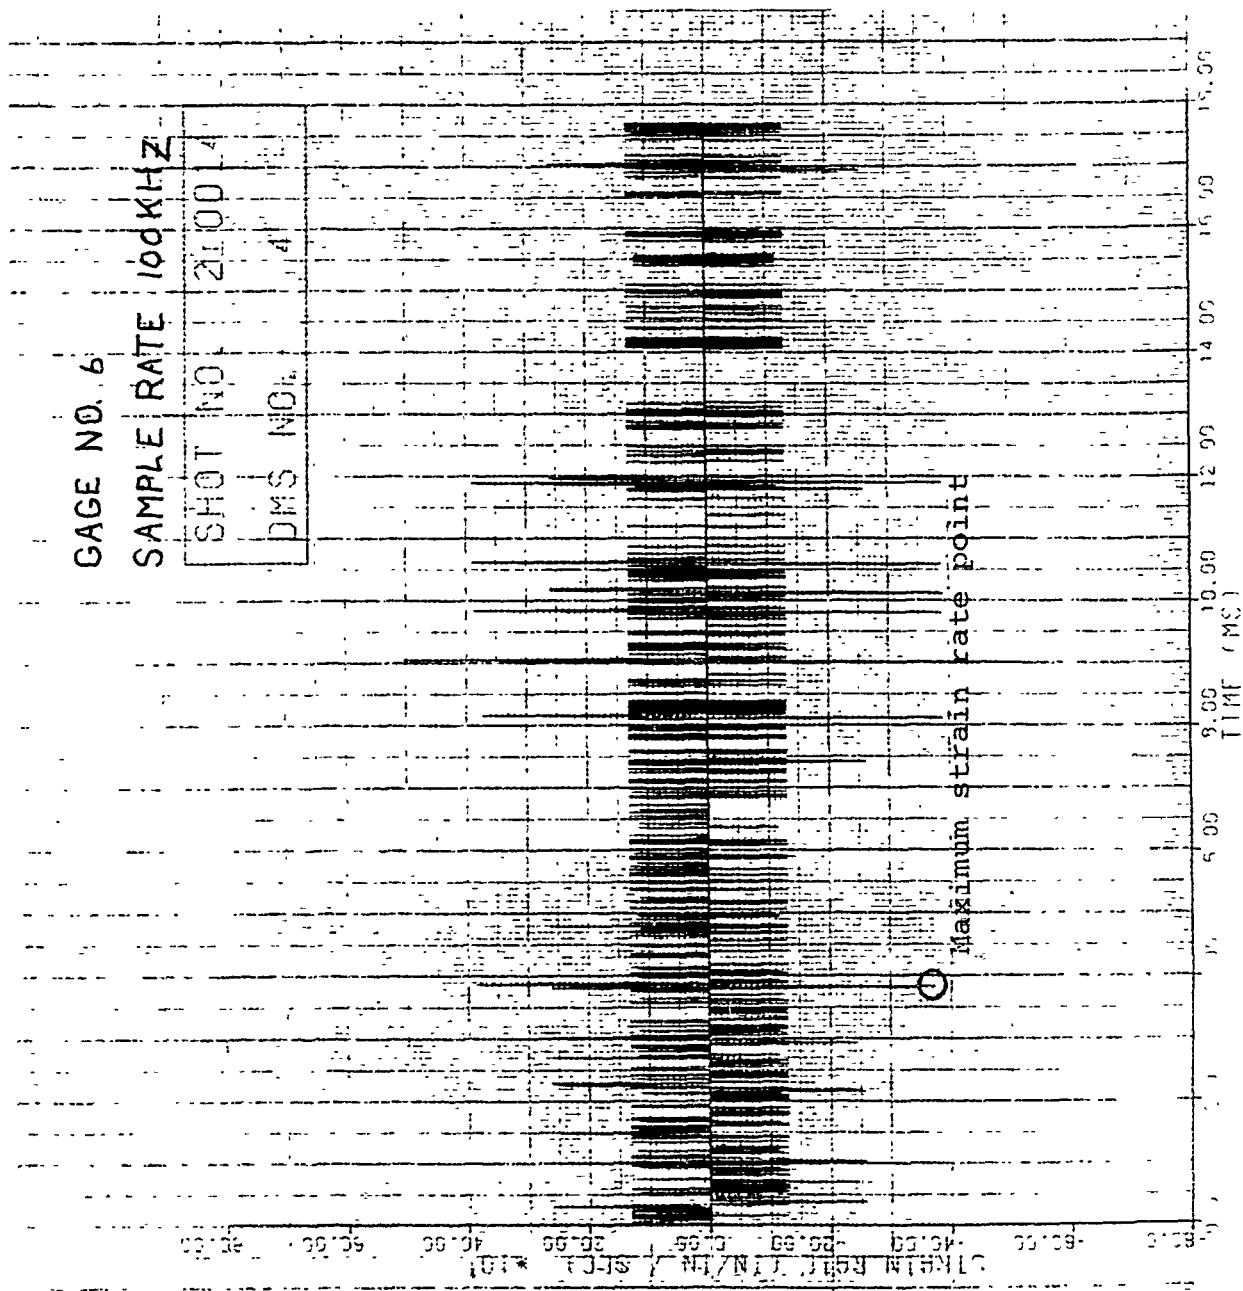
For Shot 2-0014 at a velocity of 170 m/s and impact mass of 37.0 g, the highest strain rate for the 30 percent span impacts was 372 in/in/sec for the 680 g (1.5 pound) bird as identified in Figures 222 and 223. Figure 222 gives the strain versus time plot while Figure 223 gives the strain rate versus time plot. The strain data for this impact is contained in the Volume II report. This strain rate value was for a gage located on the midchord at the blade root in the span-wise direction. The strain gage locations are given in Figure 2A of Appendix A. No visible damage was received by the blade for this impact.

Figure 222. Strain of Shot 2-0014 for Gage #6.

Figure 223. Strain Rate of Shot 2-0014 for Gage #6.

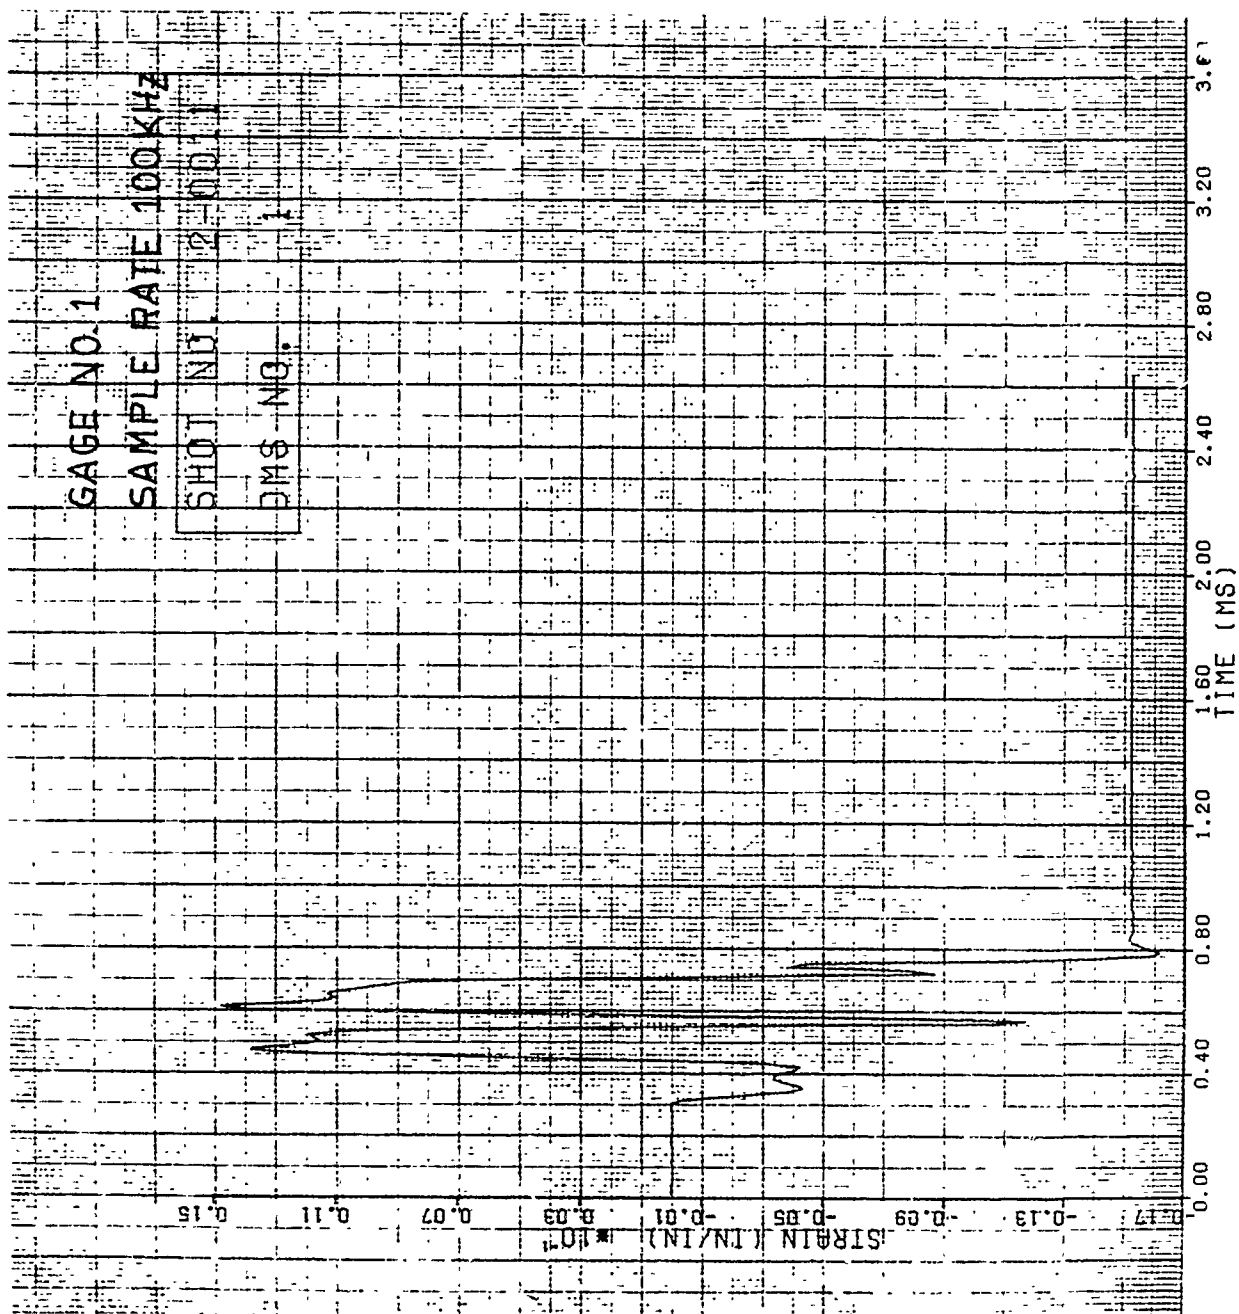
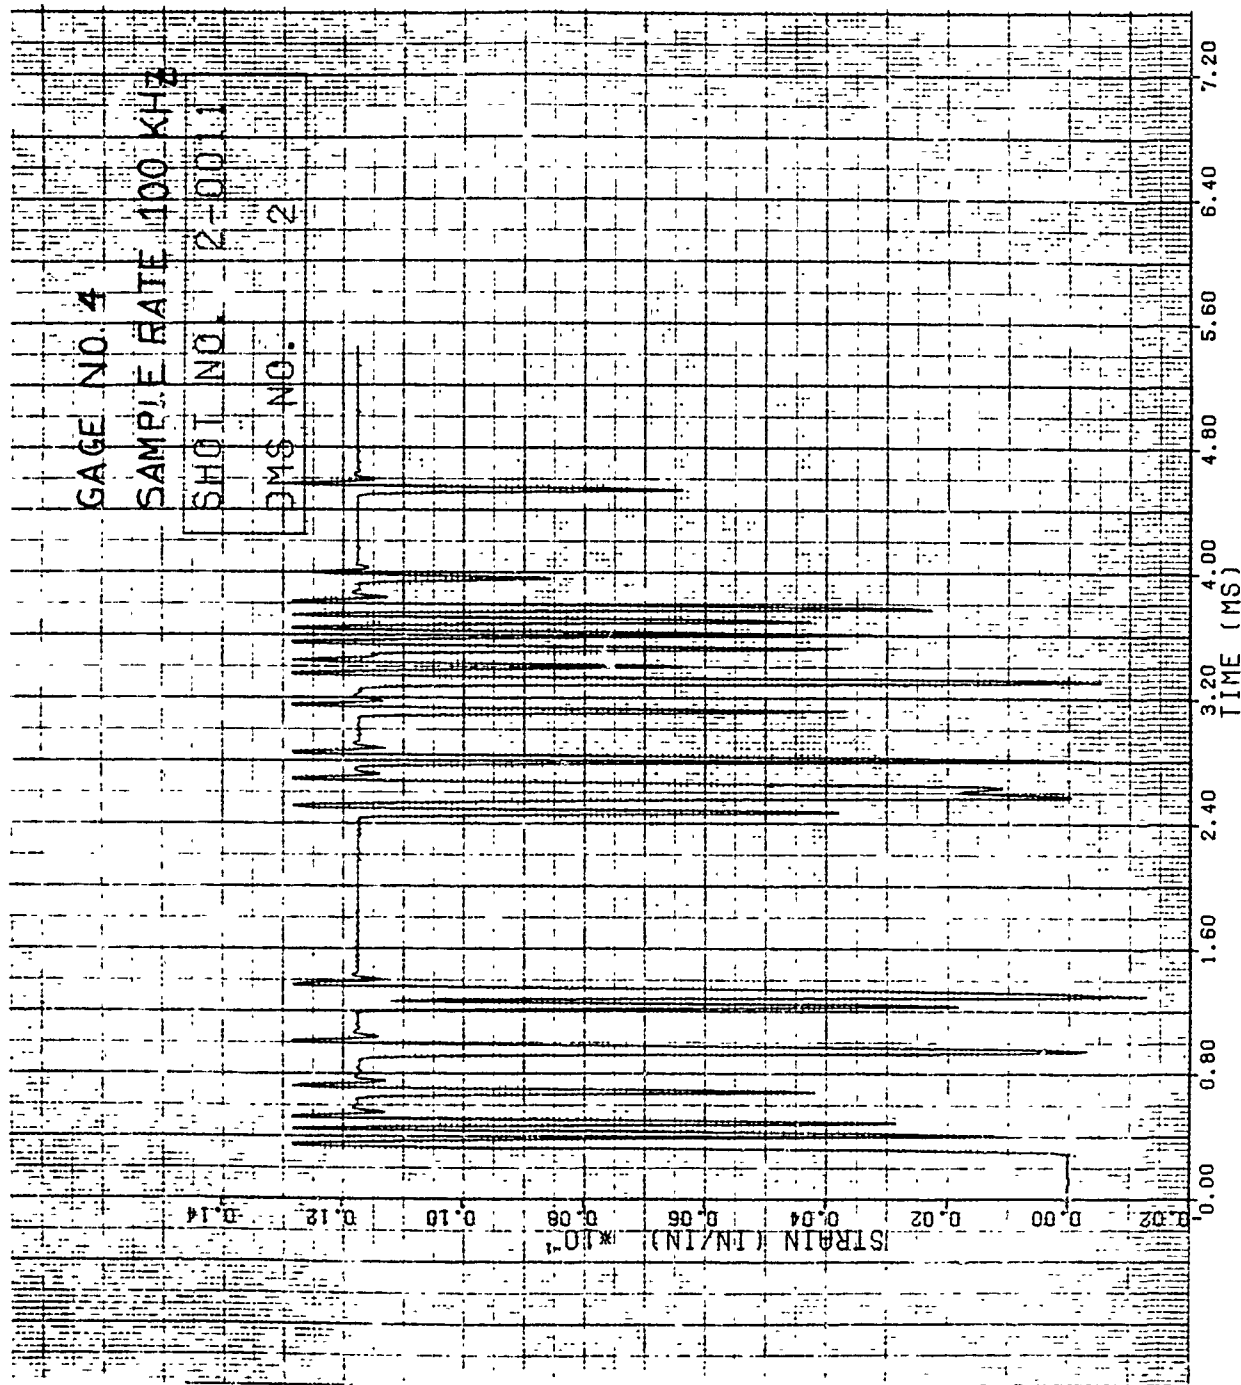
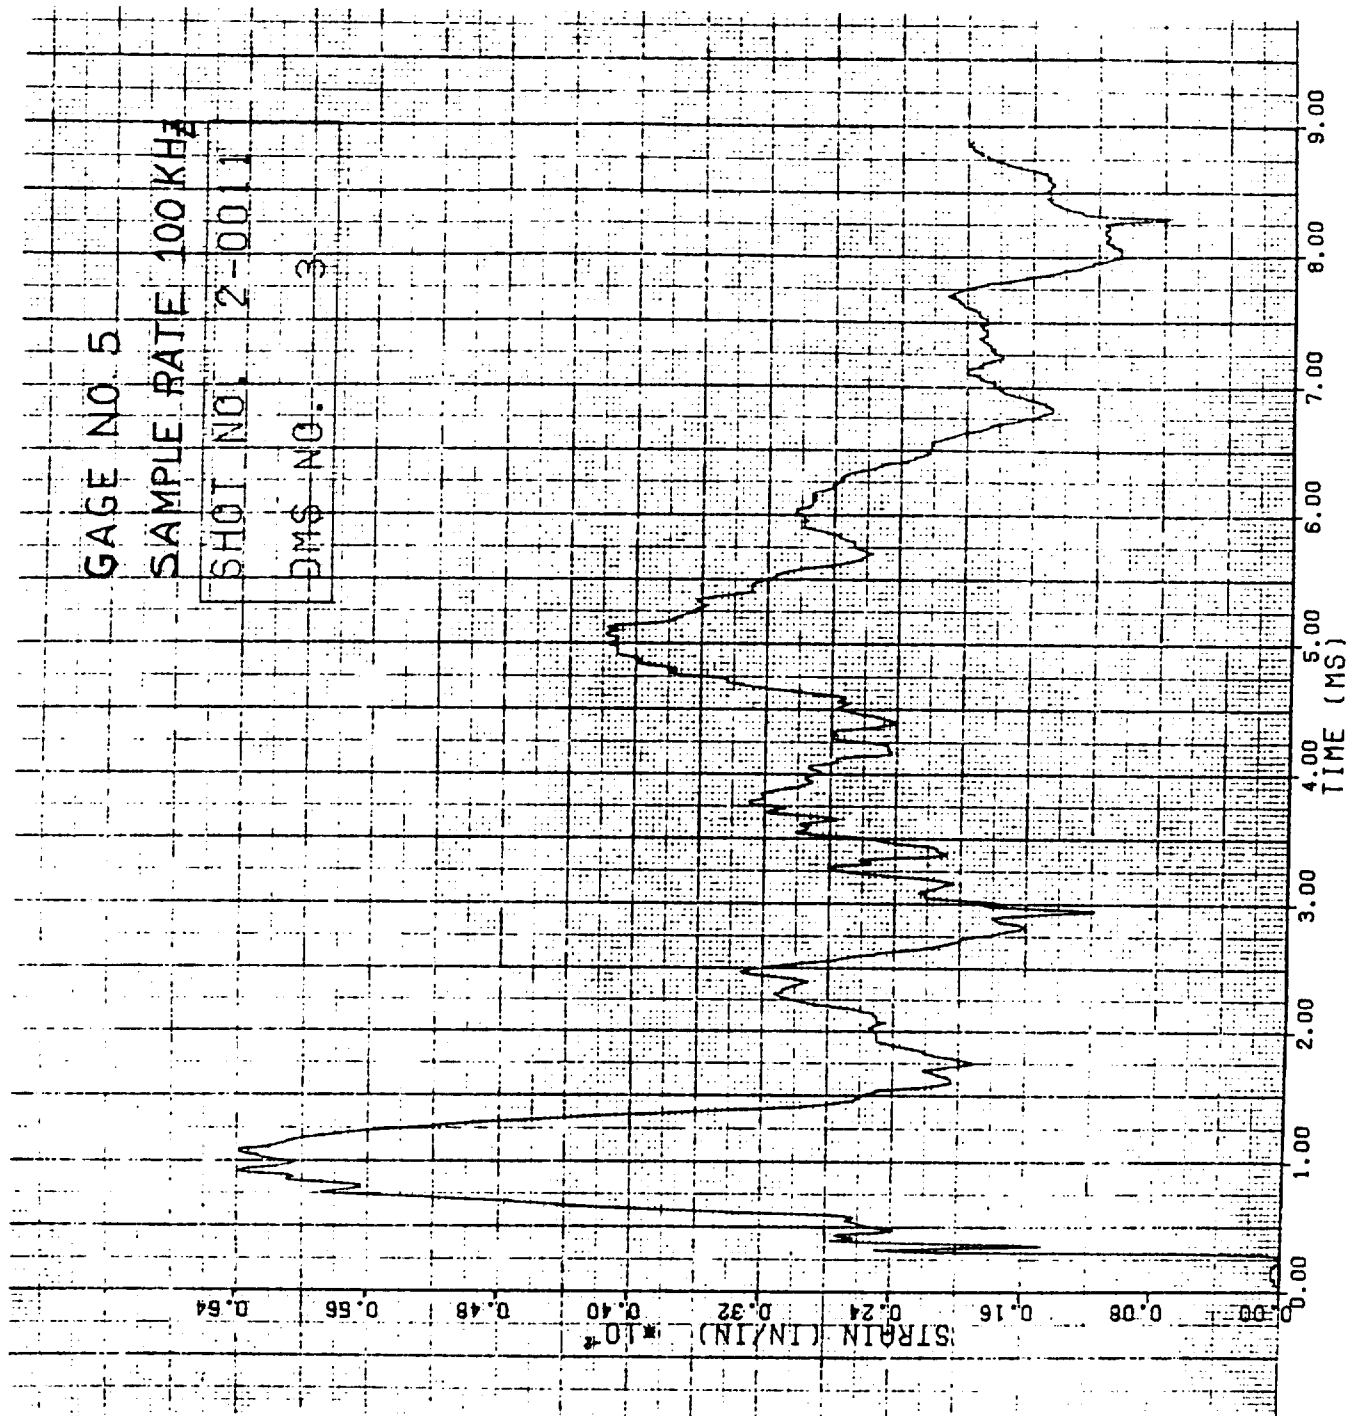
Typical strain versus time curves are given in Figures 224 through 229 for Shot 2-0011. The impact velocity was 161 m/s and impact mass of 94.9 g generated slight damage on the blade. Tension is denoted as a negative strain and compression as a positive strain in the strain data curves for all the impacts in this blade group.

Figure 224. Strain of Shot 2-0011 for Gage #1.

Figure 225. Strain of Shot 2-0011 for Gage #4.

Figure 226. Strain of Shot 2-0011 for Gage #5.

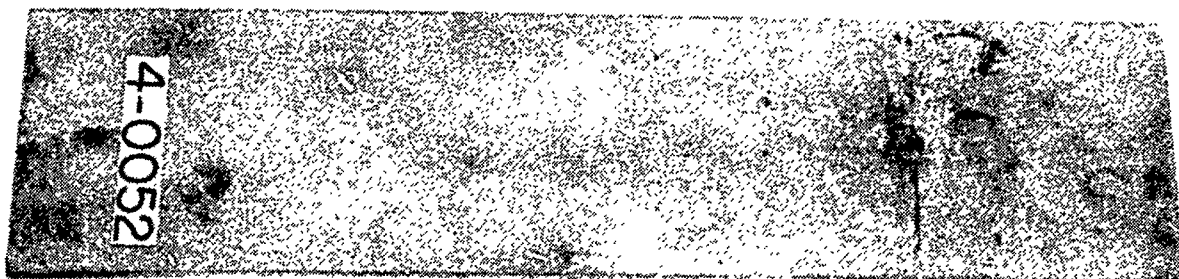
Figure 2B. Damage for Group 1 Titanium Specimen for 85 g
(3 ounce) Artificial Bird Impact (Shot 4-0052).

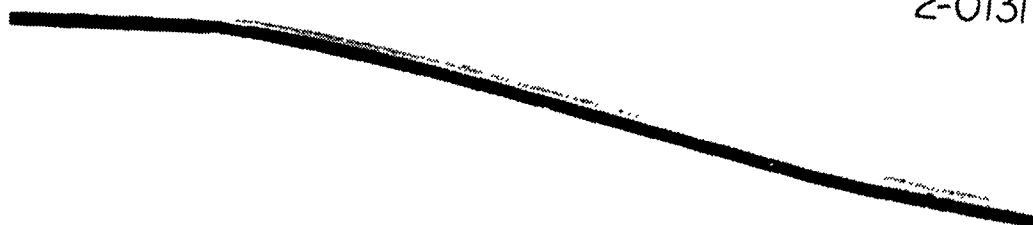
Figure 3B. Specimen Due to 85 g (3 ounce) Artificial Bird Impact (Shot 2-0131).

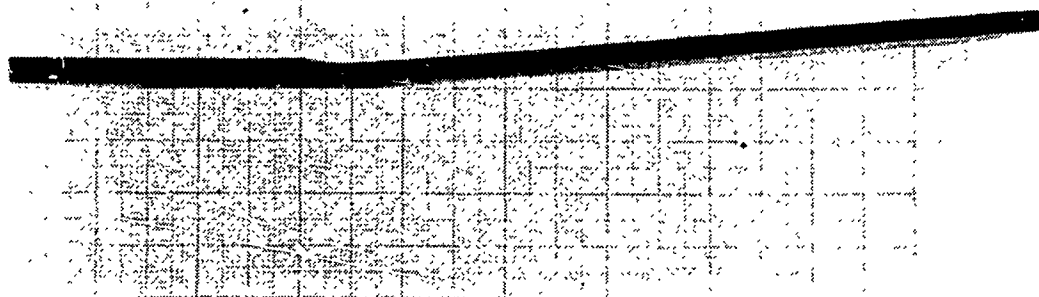
2-0096

Figure 7B. Damage for Group 4 Titanium Specimen for 85 g
(3 ounce) Artificial Bird Impact (Shot 2-0096).

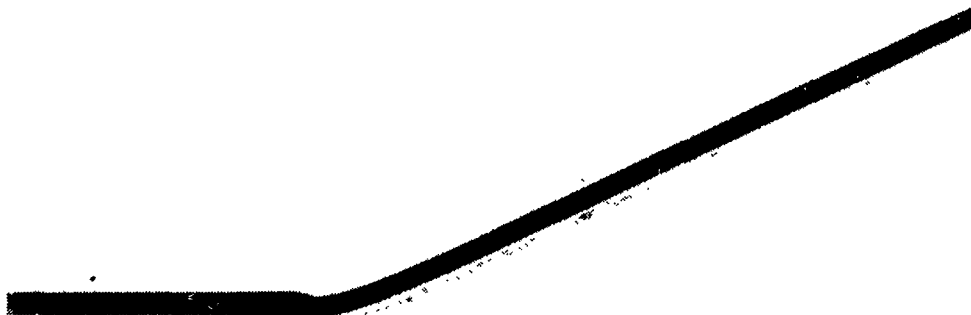
2-0098

Figure 9B. Damage for Group 4 Titanium Specimen for 85 g
(3 ounce) Artificial Bird Impact (Shot 2-0098).

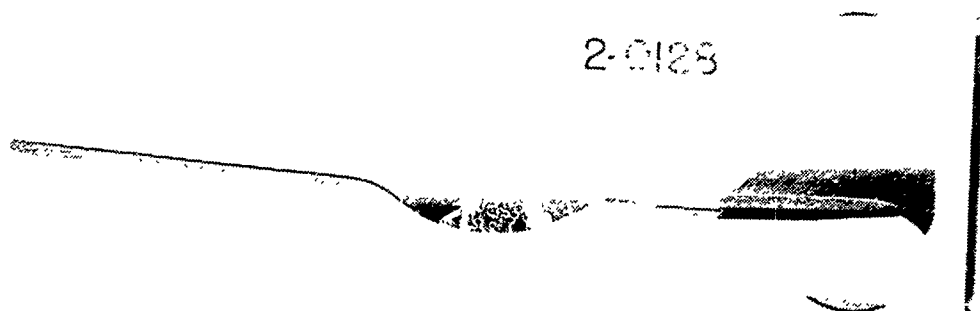
2-0128

Figure 15B. Damage for Group 7 Titanium Specimen Due to 85 g (3 ounce) Artificial Bird Impact (Shot 2-0128).

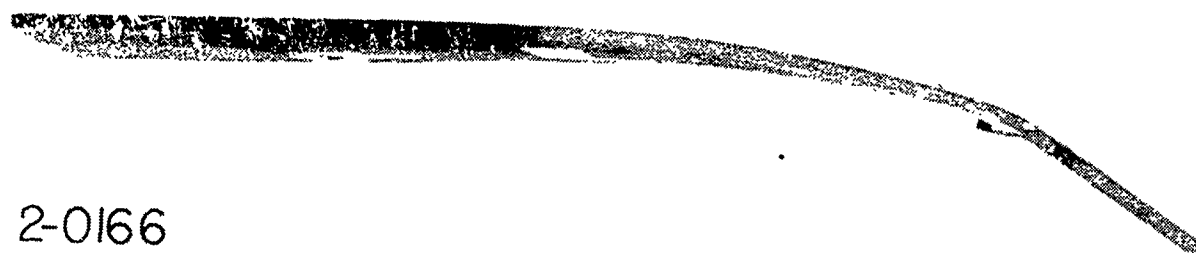
Figure 18B. Damage for Group 8 Titanium Specimen Due to 85 g (3 ounce) Artificial Bird Impact (Shot 2-0166).

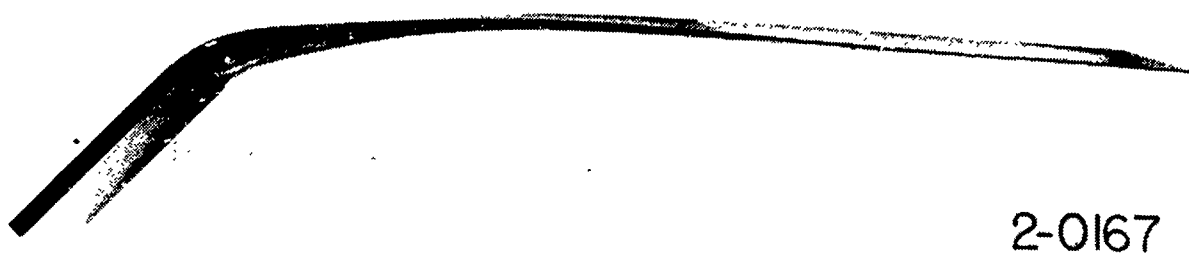
Figure 19B. Damage for Group 8 Titanium Specimen Due to 85 g (3 ounce) Artificial Bird Impact (Shot 2-0167).

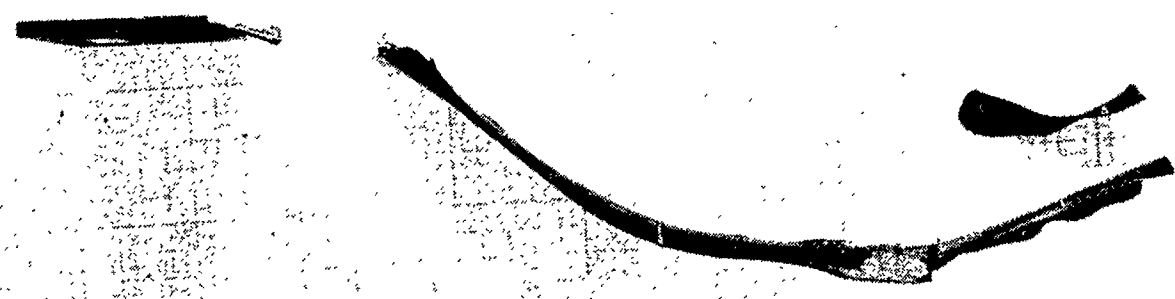
2-0192

Figure 21B. Damage for Group 9 Titanium Specimen Due to 680 g (1.5 pound) Artificial Bird Impact (Shot 2-0192).

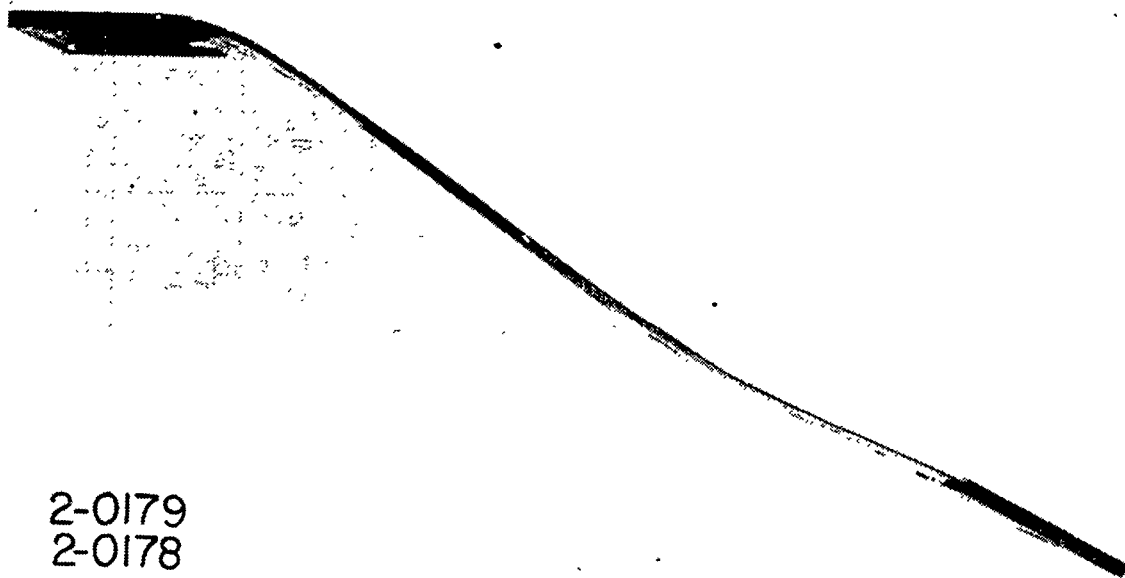
2-0179
2-0178

Figures 22B and 23B show the damage received from Shots 2-0177 and 2-0179, respectively.

Figure 23B. Damage for Group 10 Titanium Specimen Due to 85 g
(3 ounce) Artificial Bird Impact (Shot 2-0179).

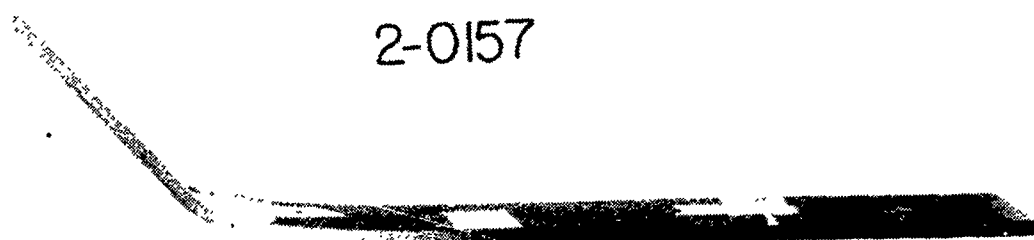
Figures 24B and 25 B show the damage generated on the specimens of Shots 2-0157 and 2-0158.

Figure 24B. Damage for Group 11 Stainless Steel Specimen Due to 680 g (1.5 pound) Artificial Bird Impact (Shot 2-0157).

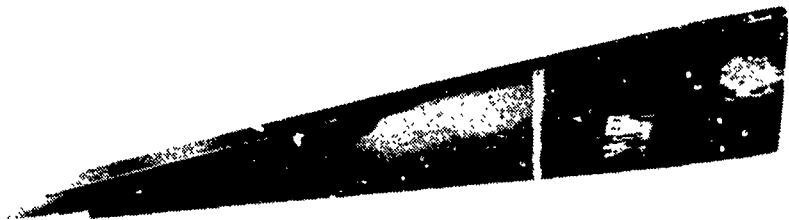
Figures 28B and 29B show the damage received for Shots 2-0161 and 2-0162, respectively.

Figure 28B. Damage for Group 13 Stainless Steel Specimen Due to 680 g (1.5 pound) Artificial Bird Impact (Shot 2-0161).

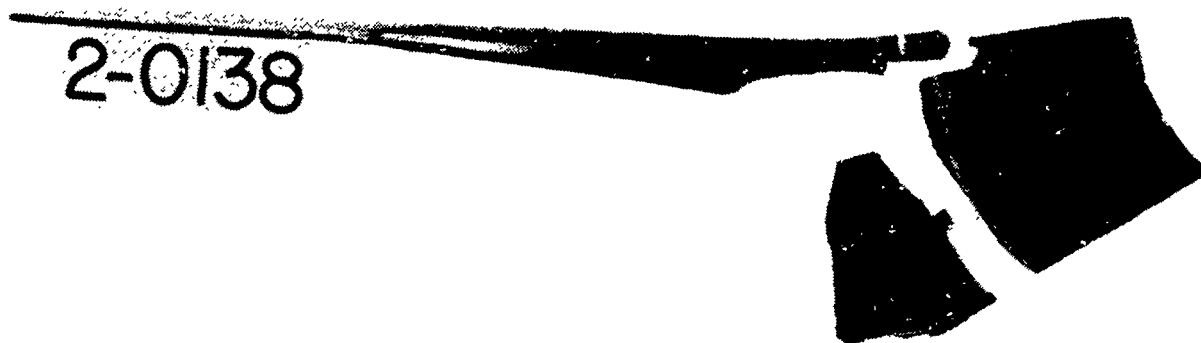
Figures 34B through 37B give photographs of the damage for the four specimens impacted in this group.

Figure 34B. Damage for Group 16 Boron/Aluminum Composite Specimen Due to 85 g (3 ounce) Artificial Bird Impact (Shot 2-0138).

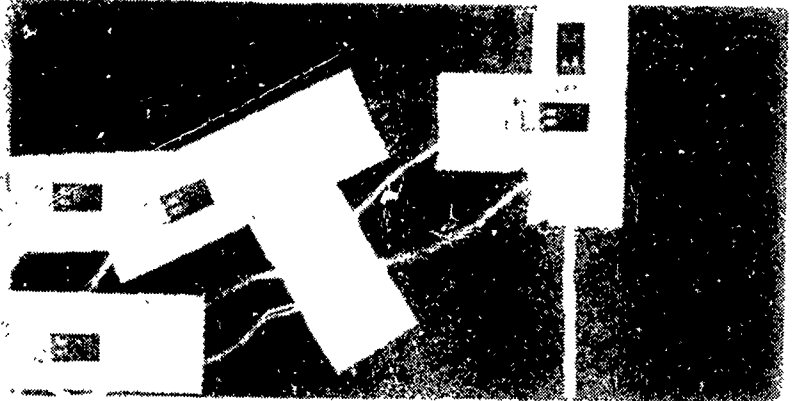
2-0142

Figure 37B. Damage for Group 16 Boron/Aluminum Composite Specimen Due to 85 g (3 ounce) Artificial Bird Impact (Shot 2-0142).

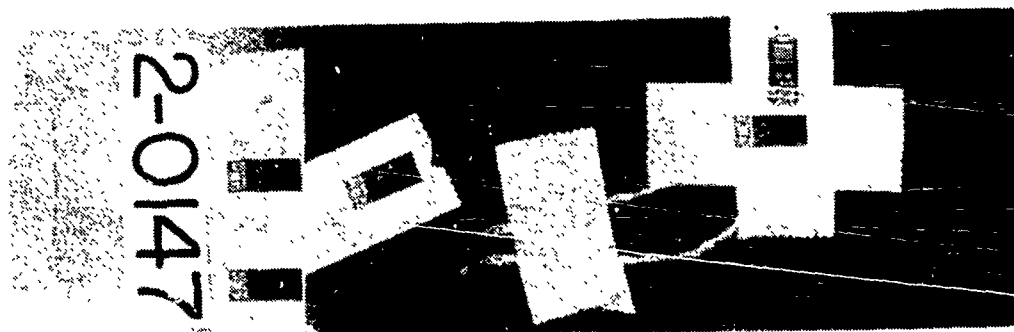
Figure 41B through 43B of Appendix B show photographs of the damage received for Shots 2-0146, 2-0147, and 2-0148, respectively.

Figure 42B. Damage for Group 19 Boron/Aluminum Composite Specimen Due to 85 g (3 ounce) Artificial Bird Impact (Shot 2-0147).

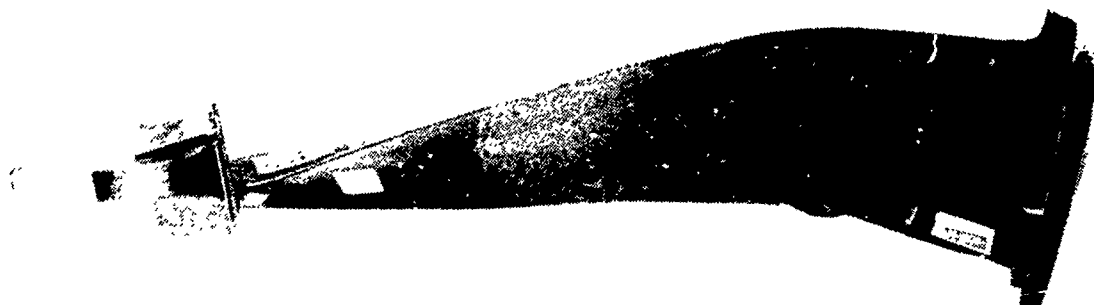
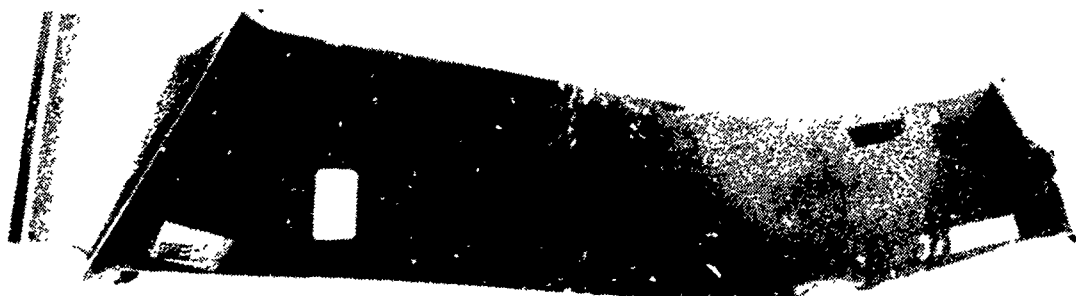
the impact site 1.78 cm for an impact mass of 105.6 g. Figure 46B shows the damage for Shot 2-0201. The strain data for Shot 2-0201 are given in Figures 186 through 191. The strain gage location for these impacts are given in Figure 4A of Appendix A. Tension for these impacts is denoted as a positive strain and compression as a negative strain.

Figure 46B. Damage for Group 4B F101 Titanium Blade Due to 680 g (1.5 pound) Artificial Bird Impact (Shot 2-0201).

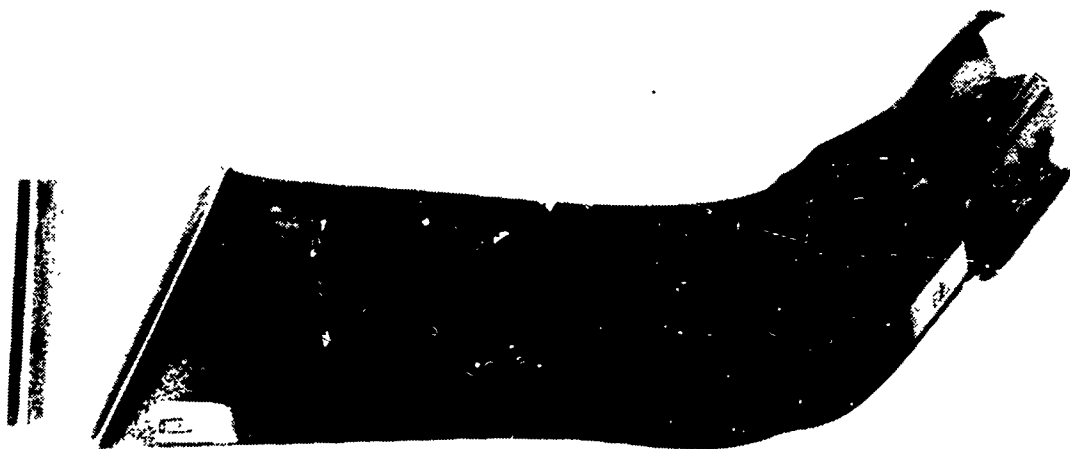
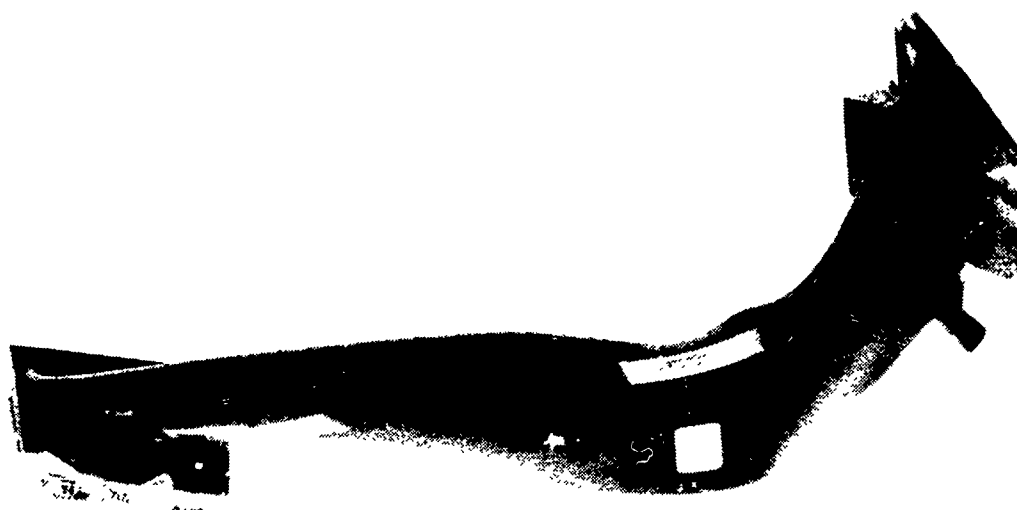
The strain versus time curves for Shot 2-0231 are given in Figures 198 through 203. Tension is denoted by a positive strain and compression by a negative strain. The location of the strain gages is given in Figure 4A of Appendix A. Photographs of the damage of Shot 2-0231 are given in Figure 47B.

Figure 47B. Damage for Group 5B F101 Titanium Blade Due to Ice Cylinder (Slab Ice) Impact (Shot 2-0231).

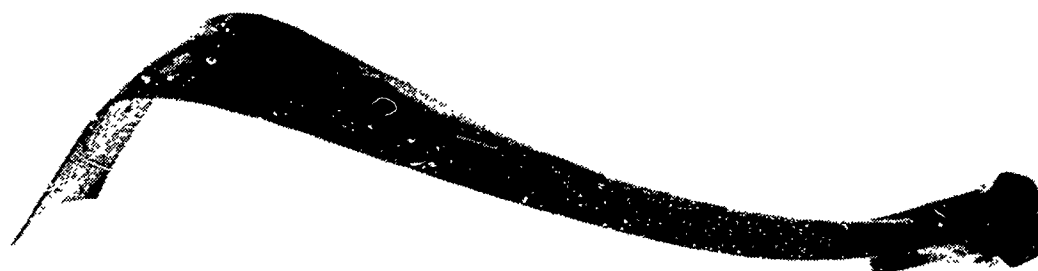
Figure 48B. Damage for Group 7B J79 Stainless Steel Blade Due to 85 g (3 ounce) Artificial Bird Impact (Shot 2-0021).

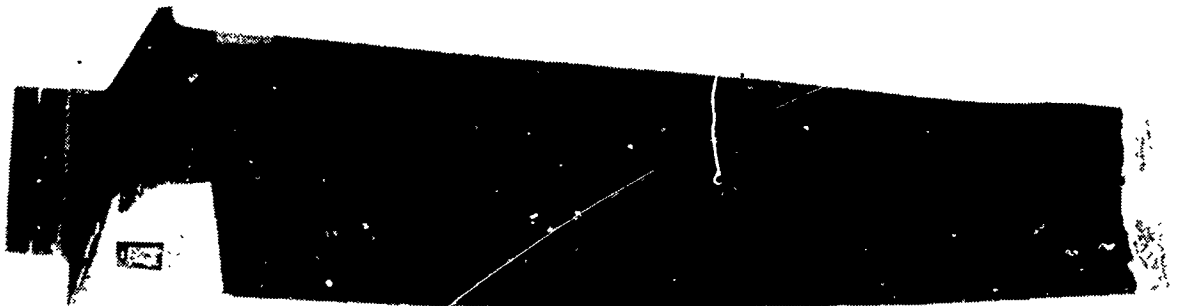
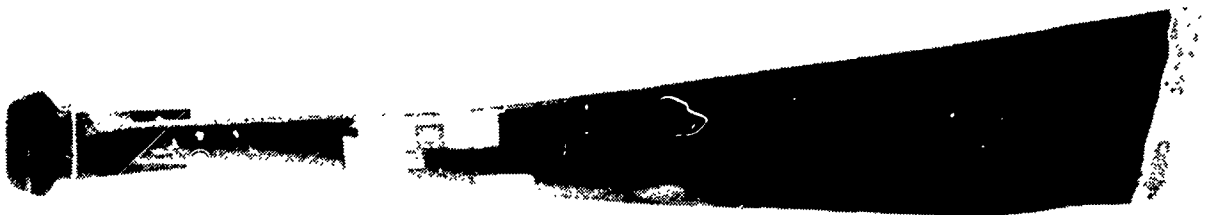
free span was received for Shot 2-0222 at a velocity of 248 m/s. The tip displacement measured for this impact was 2.24 cm. Figure 51B gives photographs of the damage of Shot 2-0222.

Figure 51B. Damage for Group 10B J79 Stainless Steel Blade Due to 5.08 cm (2.0 inch) Ice Ball Impact (Shot 2-0222).

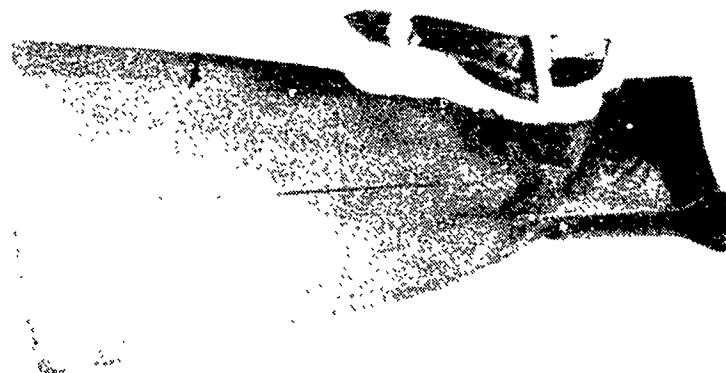
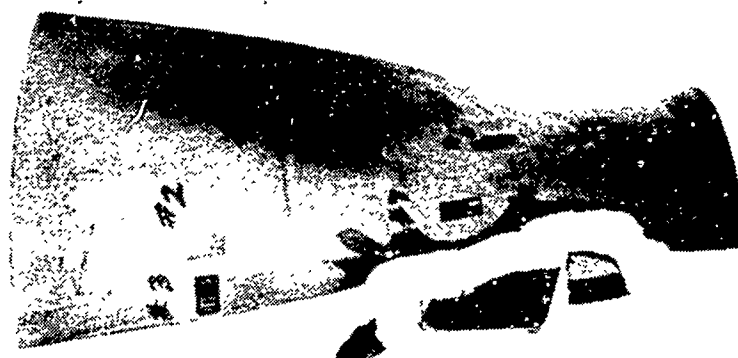
Figure 54B. Damage for Group 12B APSI Boron/Aluminum Composite Blade Due to 85 g (3 ounce) Artificial Bird Impact Shot 2-0016).
